Bureau of Mines Report of Investigations/1987

Analysis of Cutter Roof Failure Induced by Clastic Dikes in an Underground Coal Mine

By Eric R. Bauer and John L. Hill III

Report of Investigations 9117

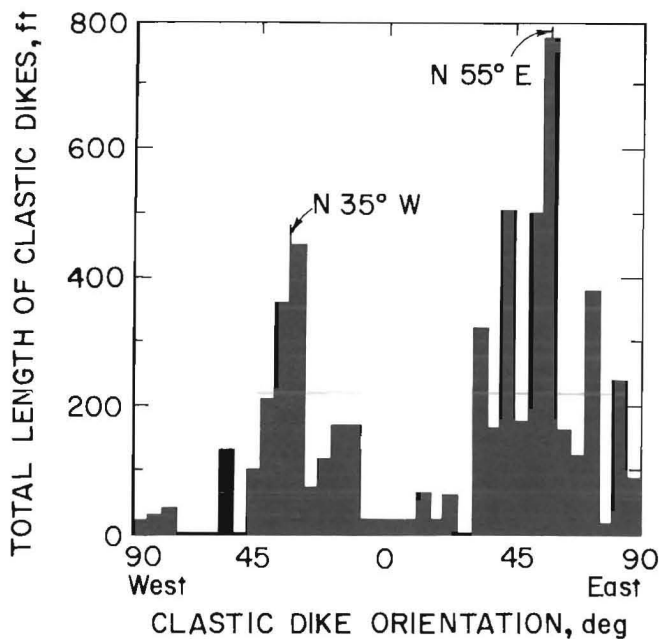
Figure 8 is a histogram of the orientations of the clastic dikes found in the Main A headings. A bimodal distribution of N 35° W and N 55° E existed, possibly due to the proximity of the syncline and the stress field present during dike formation. This bimodal distribution is significant because it is different from the orientations of the Main A entries and crosscuts, which are N 75° W and N 15° E, respectively. Although oriented for reasons other than control of the problems related to clastic dikes, Main A is being driven at a heading that minimizes the dikes' effects on roof instability.

FIGURE 8.—Histogram of clastic dike orientations in the Main A headings from the shaft to the face.

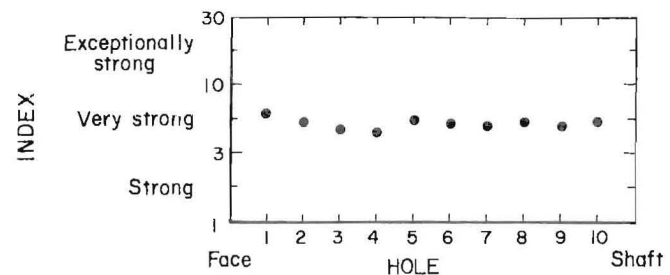
It seemed desirable to have a measure of the anisotropic nature of the rock in addition to the basic rock strength because the rock being tested was shale. The core specimens were thus subjected to axial and diametral point load tests. As figure 12 shows, rock strength, measured by Broch and Franklin's axial strength index (12), varied very little overall for each hole from one end of the main entry system to the other. The average strength value of 6.2 for the entire unit is well within the "very strong"

FIGURE 12.—Axial strength index values for each corehole. (9).

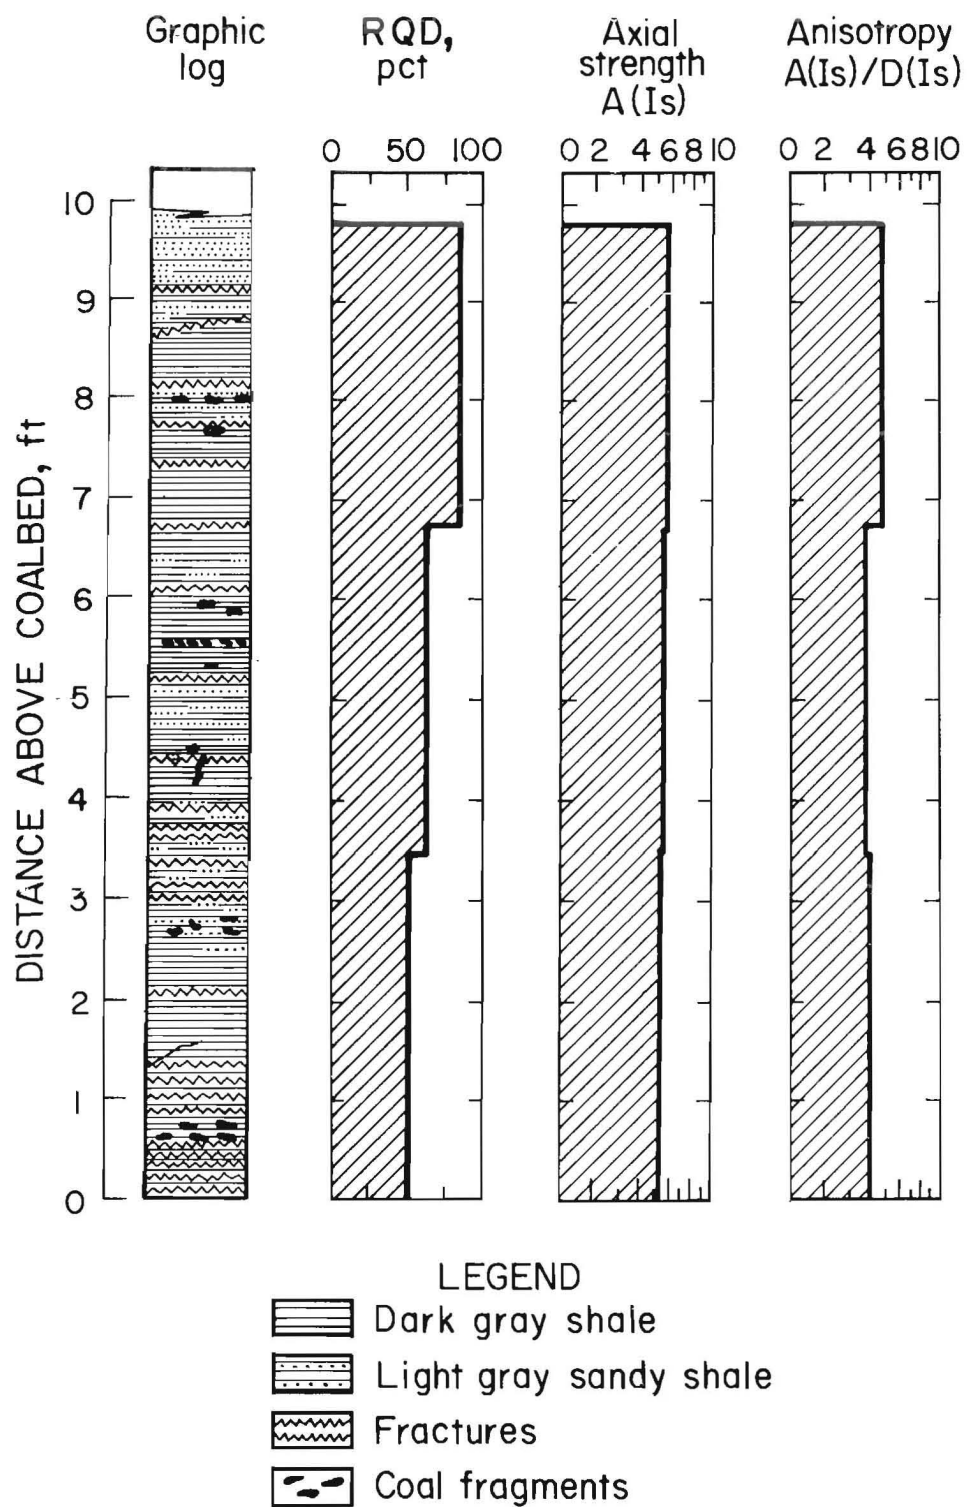
FIGURE 13.—Generalized stratigraphic column and rock properties in the Main A roof.
 Note: $D(I_s)$ in the diametral strength of a specimen determined from point load tests.

designation. Figure 13 is a cumulative diagram of the assessment made of the immediate 10 ft of roof rock. The stratigraphic column, RQD, axial strength, and anisotropic value are all averaged values to represent the entire main entry system from the shaft to the face. In general, the roof rock was comprised of two rock types within this 10-ft interval: a dark gray shale with an average compressive strength of 13,380 psi, and a light gray sandy shale with an average compressive strength of 15,280 psi.

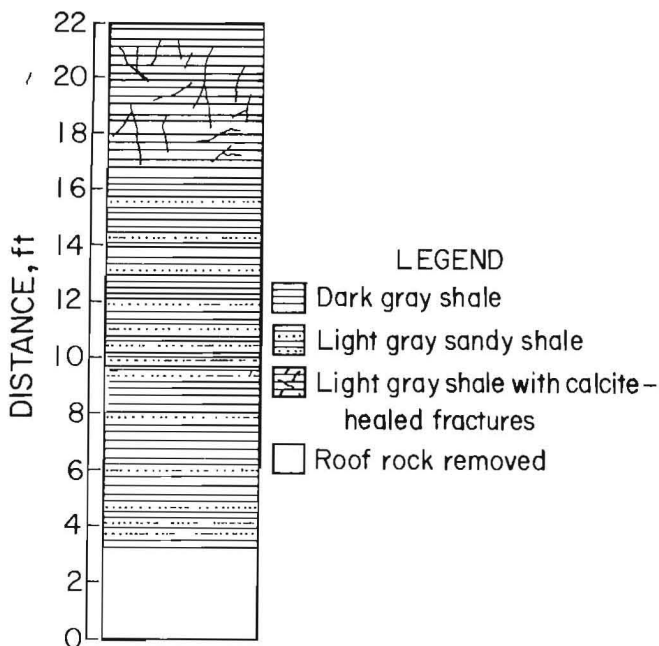
FIGURE 14.—Stratigraphic column of the roof rock at the in situ stress measurement site.

The immediate 10 ft of roof rock was identical in its characteristics to that from the other 10 coreholes, but 16.75 ft above the coalbed a light gray shale was present, which was highly fractured and healed with calcite infilling. This rock unit continued to the top of the corehole, which was 21.33 ft above the coalbed. The compressive strength of this material was very low, averaging 4,160 psi. Young's modulus and Poisson's ratio were calculated from the specimens for use in calculating in situ stress. The fractured nature of the specimens resulted in strain hardening during compression tests. The average tangent value of Young's modulus was 2.01×10^6 psi, and the average tangent value of Poisson's ratio was 0.33.

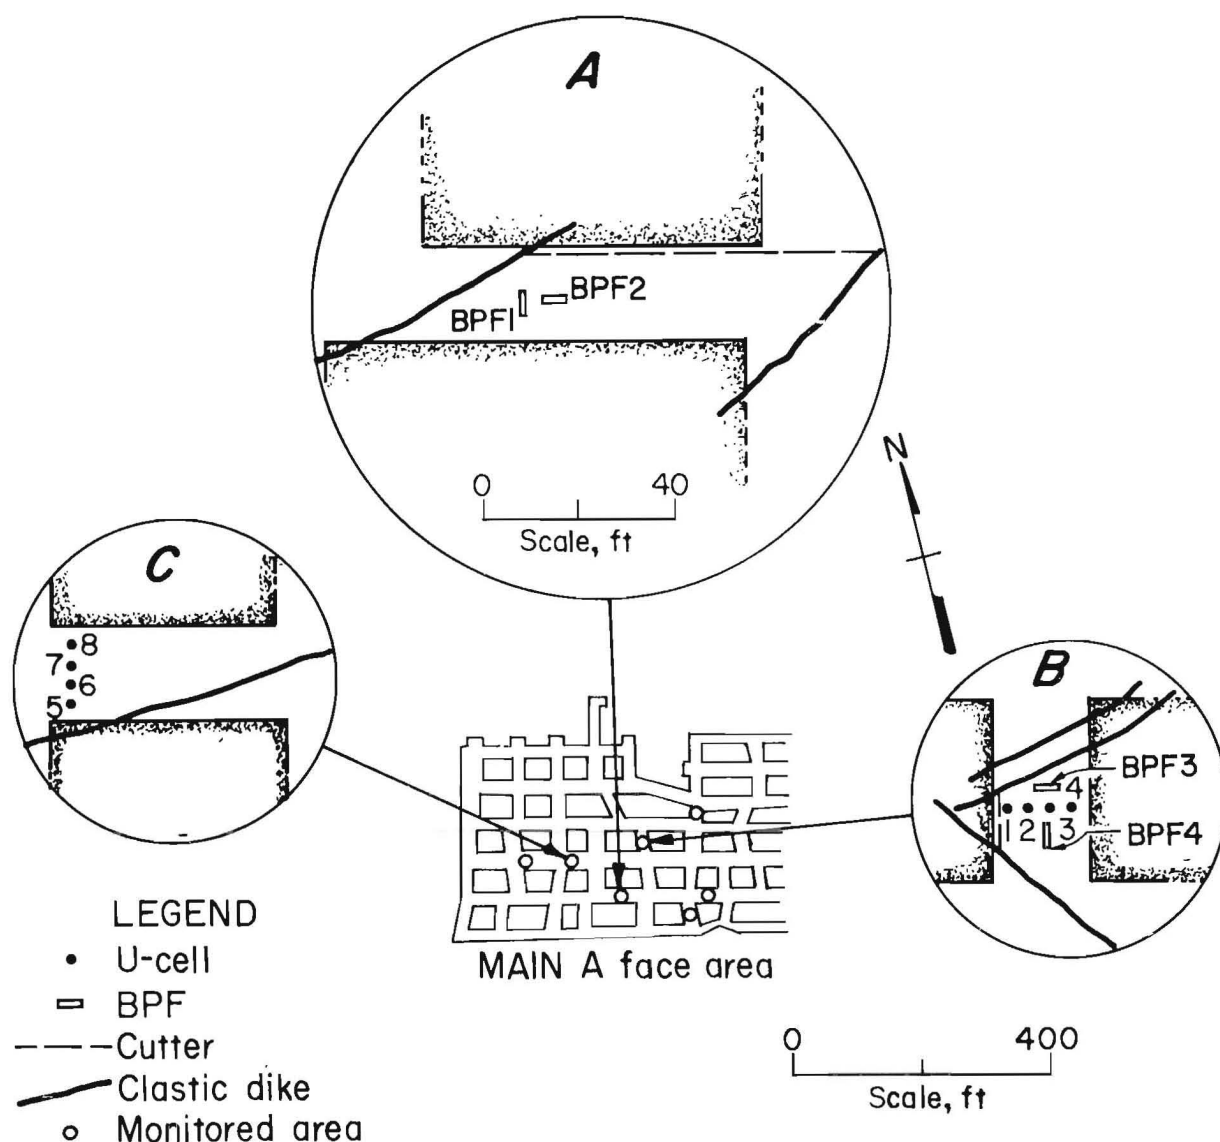
The first area monitored was in the L-1 entry of Main A; two BPF's were installed (fig. 15A). At the time of installation no cutter had formed in the entry, and the clastic dike to the west of the BPF's had not been exposed by mining. Approximately 3 days later, loading of BPF 1

FIGURE 15.—Location map of monitored areas (8).

The second area monitored was a cross-cut between the belt and track entry (fig. 15B). The clastic dikes just north of the BPF's had not yet been exposed by mining, prior to installation of the instrumentation. Based on the first experience of monitoring cutter development, it was decided that U-cells would be installed on a row of bolts across the entry to measure bolt loading in addition to using BPF's.

In the next area (fig. 15C) trusses were being used on a regular basis and had been successful in deterring the formation of cutters. Shortly after this cut was mined, some rock did fall from the clastic dike in the roof, but this activity ceased once trusses were installed. Figure 21 shows the total loading seen by each U-cell across the entry.

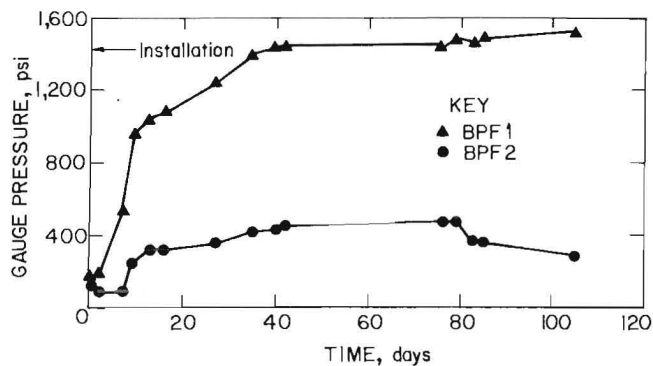
began, as mining exposed a clastic dike just inby the BPF's. BPF 1 measured pressure changes perpendicular to the heading of the entry. Six days later, both BPF's showed signs of increased loading as a cutter began to develop adjacent to the clastic dike just inby the BPF's (fig. 16). As the cutter progressed to the next outby clastic dike, the loading on BPF 1 continued to increase. By day 10, posts were installed for additional support. However, loading continued to increase on both BPF's, and roof conditions continued to deteriorate. On day 30, the entire entry had to be cribbed to control the roof. Loading eventually leveled off as the cribs took

FIGURE 16.—Pressure monitoring behavior of BPF's 1 and 2 (8).

the load, and the entry finally stabilized. Both BPF's responded as if the roof was acting as a cantilever beam with support on the southern pillar and the cutter along the northern pillar allowing the beam of the roof to bend. The cantilever beam effect is explained in detail in the "Roof Failure Analysis" section of this report.

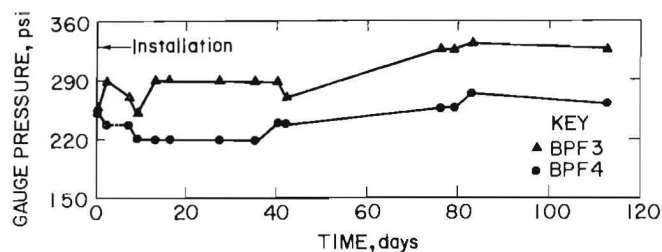
Loading of U-cell 1 and BPF 3 occurred as soon as the next 20-ft cut into the face was taken from the crosscut, exposing the two clastic dikes. BPF 3 detected pressure changes perpendicular to the entry and showed a total increase of approximately 35 psig in the first day, while BPF 4 bled off (fig. 17). Some natural bleedoff is expected as the hole deforms if there is no movement in the roof to apply pressure to the BPF or if extension occurs in the beam of the roof. By the second day, U-cell 1 (closest to the inby rib) showed an increase in load of nearly 290 psig as a cutter began to develop along the inby rib between the

FIGURE 17.—Pressure monitoring behavior of BPF's 3 and 4 (8).

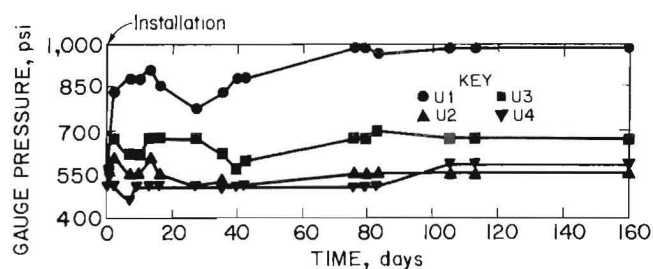
FIGURE 18.—Bolt load monitoring behavior of U-cells 1-4 (8).

clastic dikes intersecting the rib (fig. 18). From past experience with cutters developing this quickly, it was suggested that supplemental support be installed immediately. Trusses were installed between the rows of bolts (day 3), resulting in an immediate decrease in the rate of loading (fig. 19). The addition of trusses effectively reunited the natural beam of the roof and prevented the roof from deteriorating further. Finally, loading leveled off and the cutter did not become any more severe. Figure 20 summarizes the maximum load seen by each U-cell in the crosscut. Once again, the loading roughly paralleled that which would occur from a cantilever beam.

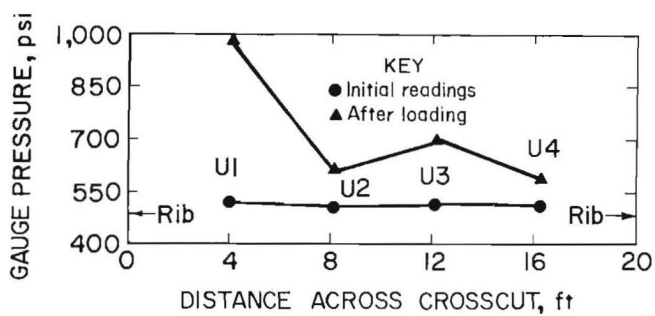
FIGURE 20.—Initial and maximum loads for U-cells 1-4 across the crosscut shown in figure 15B (8).

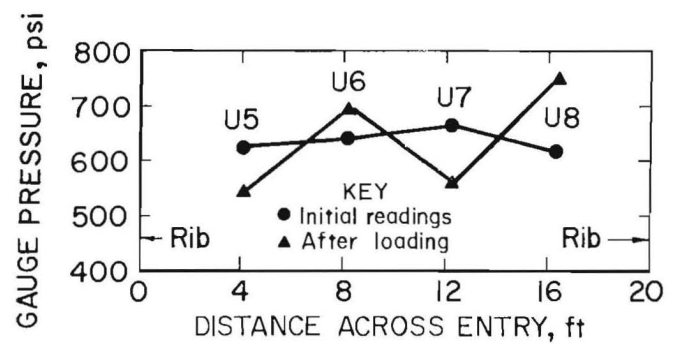
FIGURE 21.—Initial and maximum load changes for U-cells 5-8 across the entry shown in figure 15C (8).

Very little loading occurred on U-cells 6 and 8, while U-cells 5 and 7 actually bled off. Bleedoff of loading on bolts is natural if there is no new inducement of load (17). Figure 22 depicts what is suspected to be happening prior to and after roof truss installation. Just after mining and exposure of a clastic dike, the roof begins to sag, loose roof rock falls, and cutter failure initiates (fig. 22A). After the trusses are installed, the clastic dike, cutter, and

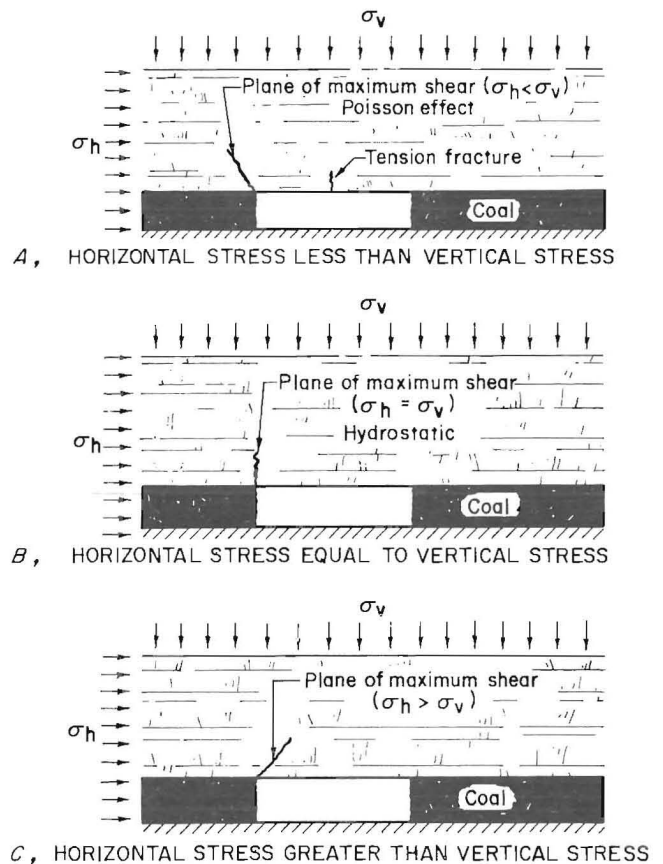
failure (fig. 26). At the test site the estimated vertical stress, based on overburden load only, is approximately 450 psi. The measured horizontal stress ranged from 305 to 620 psi, indicating the failure angle should be nearly

FIGURE 26.—Qualitative example of the influence of the horizontal stress to vertical stress on the angle of failure propagation (7).

vertical or slightly inclined out over the entries. Underground observations of cutter failure and roof falls have shown this to be the case. At some time in the past the horizontal stress may have been greater than what was measured and would have had a significant impact on cutter failure, but it is likely that some stress relieving has occurred during entry development. The most logical reason for the stress relief is that the numerous fractures and roof falls near the test site have provided avenues for the strata to move and release the in situ stresses.

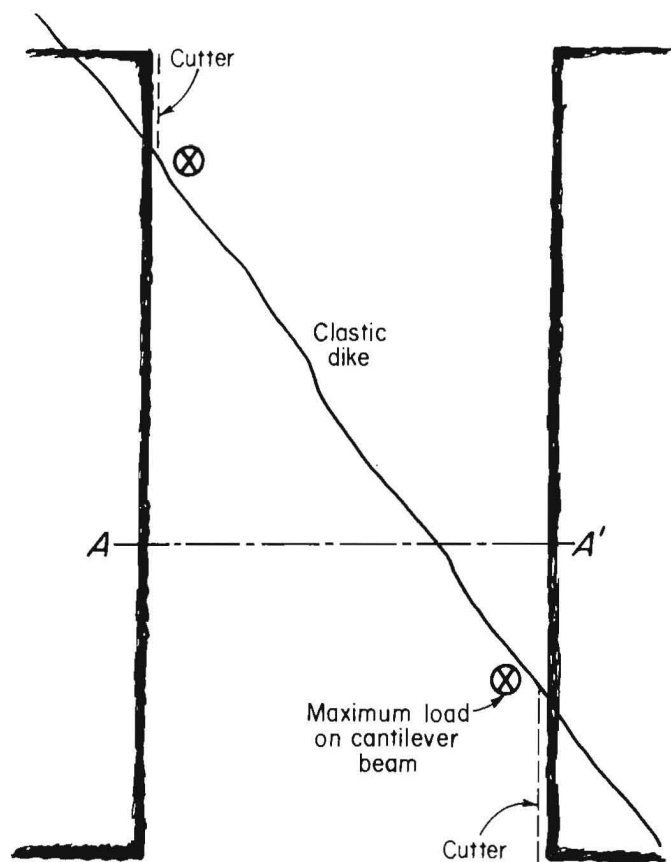
Observations made during mapping revealed that cutters mainly formed adjacent to clastic dikes shortly after mining. This suggested that the disruption of roof integrity, due to the presence of clastic dikes, contributed to the propagation of cutters. The natural beam of the roof rock, spanning from pillar to pillar, is severed when a clastic dike is present, causing the roof to behave as a cantilever beam (fig. 27). In most cases, the cutters formed at the obtuse angle of the clastic dike-rib intersection, propagating inby or outby depending on the situation. They initiate at this location because it is where the maximum load on the beam occurs and thus is the most susceptible failure point.

Simply stated a cantilever beam has one end free while the other is fixed, with maximum deflection occurring at the free end and maximum vertical shear forces at the hinged end (fig. 28) (20). Applying this principle to cutter roof failure, as a cutter forms at one roof-rib intersection (clastic dike-rib intersection), the free end of the beam is created. The fixed end is found at the other roof-rib intersection. As the free end of the roof beam deflects downward, internal stresses develop. When the roof is considered to be a series of thin plates, with only friction between the layers to resist movement, shear slip will develop along fractures and bedding planes, parallel to the beam, with the maximum

FIGURE 27.—Schematic of cantilever beam effect that occurs during cutter roof failure (8).

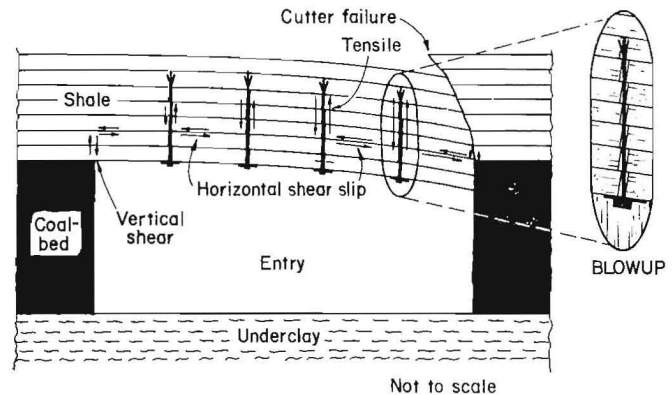
horizontal shear slip at the free end of the beam (fig. 29) (21-22). An increase in bolt loading (tension) will be induced by the shear slip only, because the bolts do not extend through the beam and into the solid roof above.

FIGURE 29.—Schematic of forces in roof strata subject to cantilever beam failure.

This cantilever beam scenario was evident in the results of the rock pressure monitoring. Increased bolt loading was measured as cutter failure progressed, with the maximum increase found next to the cutter (the free end of the beam where the shear slip was greatest). Decreased loading was detected after trusses were installed, a result of reducing the shear slip by eliminating some of the downward deflection of the cantilever beam. Additionally, the pressure increases in the roof strata measured by BPF's were indicative of a cantilever beam. The BPF's were detecting the shear slip along the bedding planes parallel to the beam. Thus all measurements and observations support the contention that the roof is failing as a cantilever beam.
